REPORT OF COAL-MINE BUMP

BEATRICE MINE
BEATRICE POCAHONTAS COMPANY
KEEN MOUNTAIN, BUCHANAN COUNTY, VIRGINIA

January 26, 1973

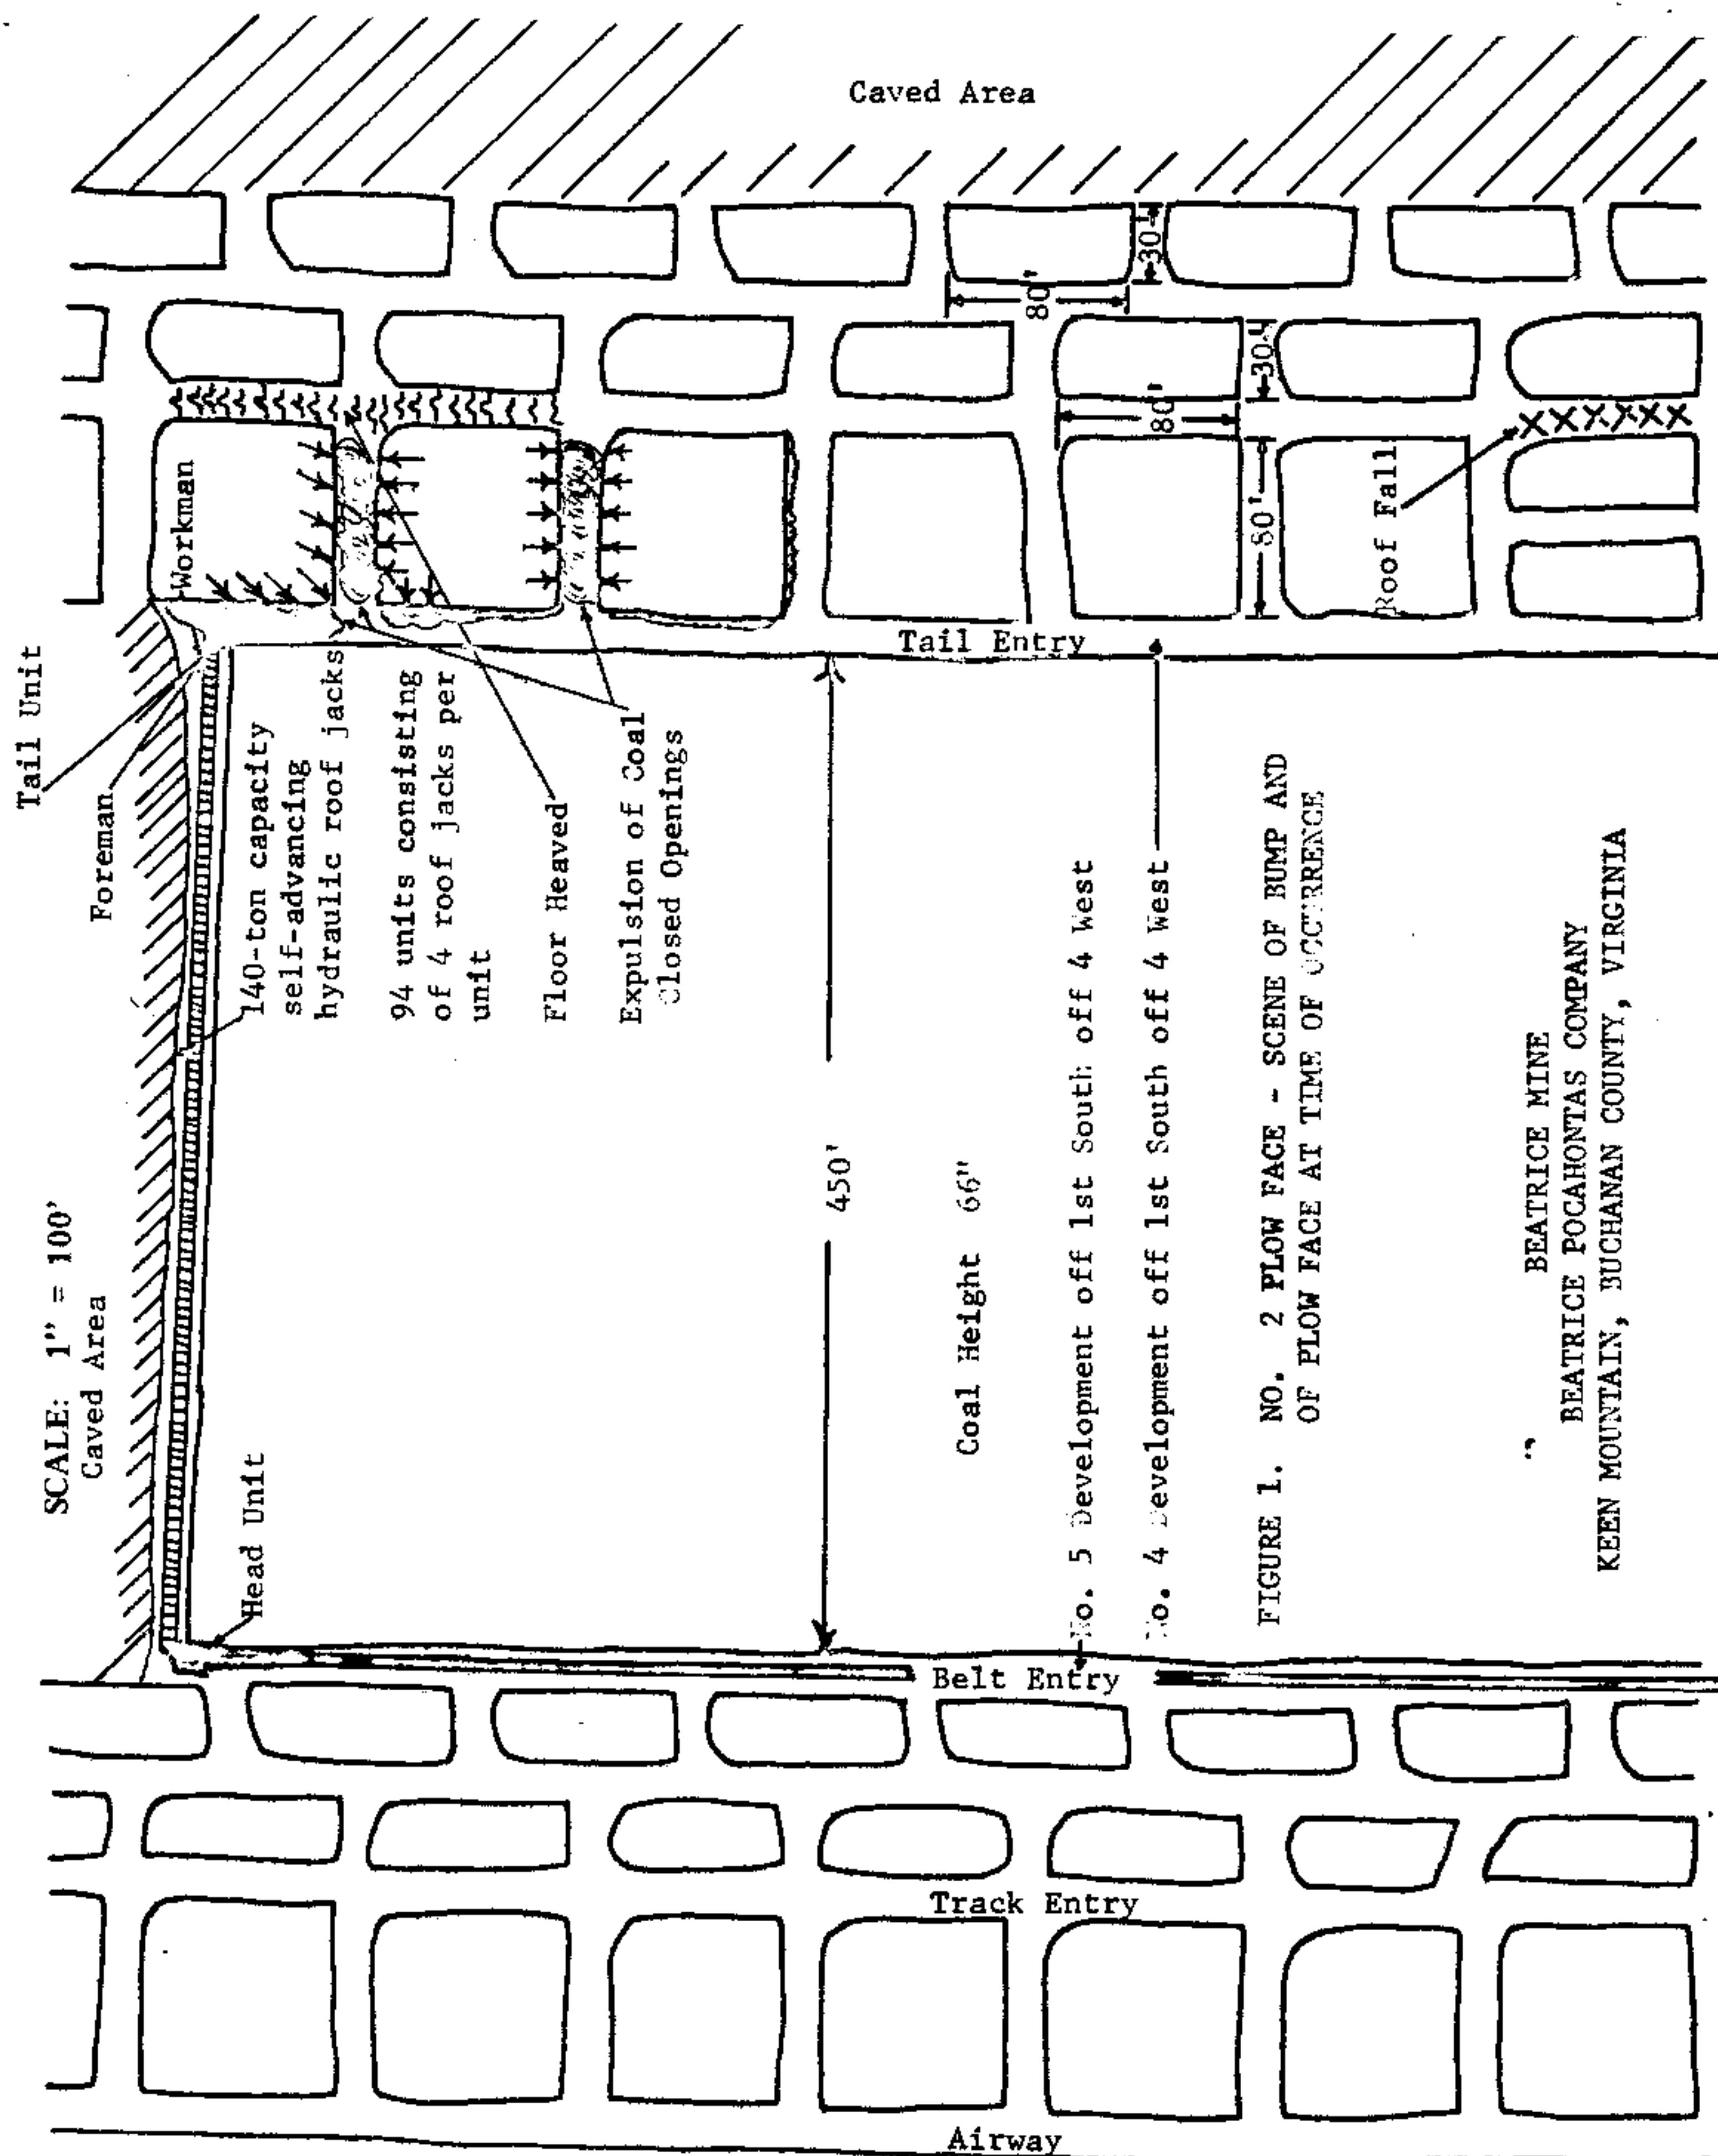
FIGURE 1. NO. 2 FLOW FACE - SCENE OF BUMP AND OF FLOW FACE AT TIME OF OCCURRENCE

Reportedly, for approximately 20 minutes prior to the bump, everything was unusually quiet. Three of the tail-entry chain pillars adjacent to and extending from 35 feet inby to 245 feet outby the conveyor tail drive unit were affected. Coal was expelled violently from the three pillars; the entry between the pillar nearest the conveyor tail drive unit, and the longwall rib was completely filled with loose coal. The two crosscuts between the three pillars were also filled with loose coal (See Sketch). Pronounced floor heaves occurred in the two entries (No. 2 and 3 entries of No. 4 development panel) to the right of and adjacent to the three pillars.

2. The immediate roof in the bump area was sandstone interspersed with sandy shale up to 20 feet thick. Above this stratum were massive sandstone beds, 20 feet to 30 feet in thickness, separated by thin shale layers generally less than 3 feet in thickness.
3. A dense overburden thickness in the bump area of 2,485 feet.
4. The ability of the coal to store up large amounts of strain energy while under compression and constraint.
5. The coal became overstressed and its stored energy was released with sudden violence causing the coal burst or bump.

During development of longwall access entries, management shall keep a record of the floor and roof structures and when roof and floor conditions are encountered, that may be conducive to coal outbursts, the Bureau of Mines shall be notified prior to longwall mining in the area so that predetermined pillars can be instrumented and the build-up of roof stresses evaluated so as to foretell the possibility of coal outbursts.
